Getting a few bumps and scrapes while **Sprint 15** racing is pretty inevitable whether it be your fault or someone else's, but just now and then you get that BUMP that requires more than a bit of gelcoat and a quick rub down, as was the case for myself at the **Sprint 15 Sport Nationals** at Instow.

## **Key to Stages of repair below :**

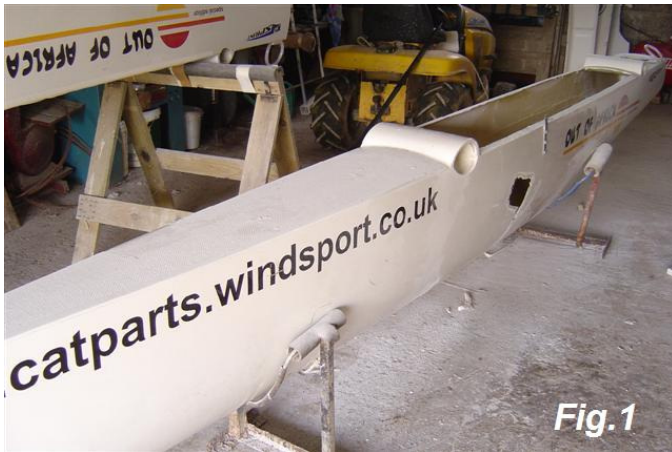
Fig.1

The damage had holed the boat on the port hull, broken away the spacer, dislodged the storage unit and put a nice Sprint 15 shaped vee in the hull side.

Fig.1:- Deck off , damage cut back , ready to start rebuild

With the deck off and the storage box out, the internal repair was started by cutting out the damaged area and laying up a temporary mould on the hull to replicate the hull shape. Using the same lay up as when the boat was built, a replacement section was moulded and laminated into place with a small overlap flange to the original hull edge.

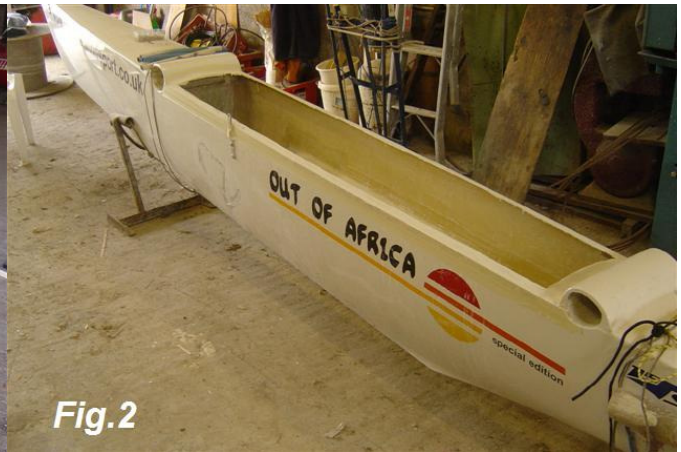
Fig.2

Fig.2:- Internal work done , ready to fit and replace deck unit.

With the inside hull work done, the flanges for holding the spacer in position were rebuilt and a

new spacer fitted. The boat was then ready for re-decking, although the deck and hull flanges needed a bit of attention so that they meet neatly.

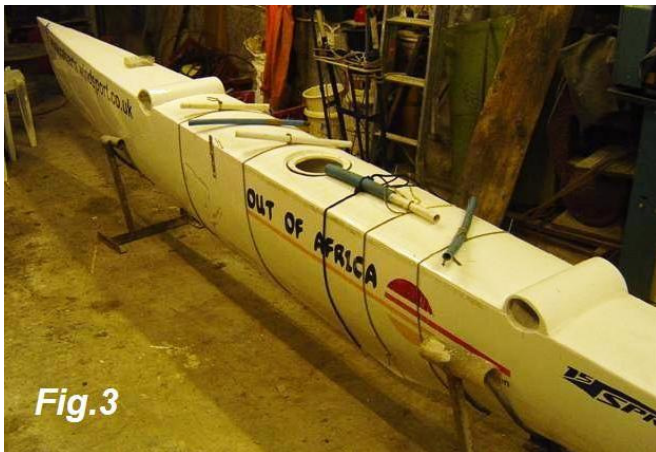
Fig.3

Fig.3:- Deck joint curing , while the "Spanish clamps" hold the deck line in position.

With the storage unit glassed back in position to the underside of the deck, a dry fit for the deck /hull join is a must. Originally the deck was attached whilst the hull was in a decking jig that could move the side of the hull in and out to match the deck line. That was not an option for us but careful use of Spanish clamps (well that is what we call them) had the desired effect and are simple to adjust.

With everything ready to go, the wet fit is made using a mix of gelcoat and resin as the bond. Timing of the mix is important, as you don't want to be chasing a mix that is going hard too quickly, and still fiddling with your Spanish clamps!!

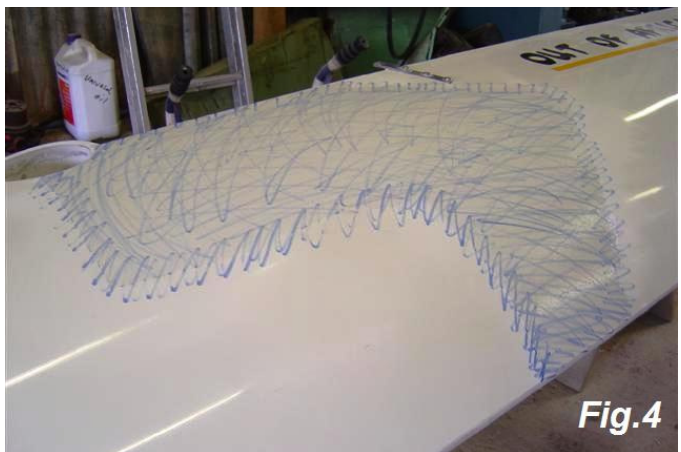
Fig.4

Fig.4:- Hull fairing taking place before final finishing.

Back to the outside of the hull, the damaged area needed fairing in, using gelcoat to build low areas, until the hull was smooth and fair from all angles. A good tip here is to use a felt tip over the area which gets rubbed off as you cut it back, something you can do with smaller repairs.

With the hull faired in, we ran a layer of spray gel over the area, blending it into the original. Colour match is tricky on any boat, unless it is very new, but white hulls have the best chance of making the repair invisible.

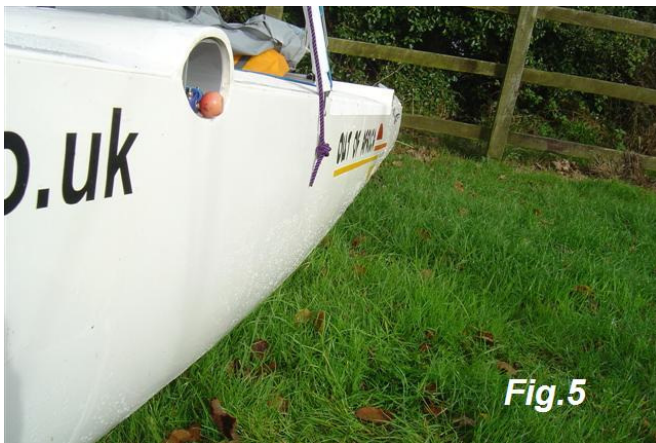
Fig.5

Fig.5:- Hull back on , and the boat ready to start racing again.

A final light cut back with 1200 paper, buff and polish, and the job was a goodun. It takes a few hours to do all this, and I would rather be sailing, but sometimes you just have to get on with it.
