Getting a few bumps and scrapes while **Sprint 15** racing is pretty inevitable whether it be your fault or someone else's, but just now and then you get that BUMP that requires more than a bit of gelcoat and a quick rub down, as was the case for myself at the **Sprint 15 Sport Nationals** at Instow.

Key to Stages of repair below :

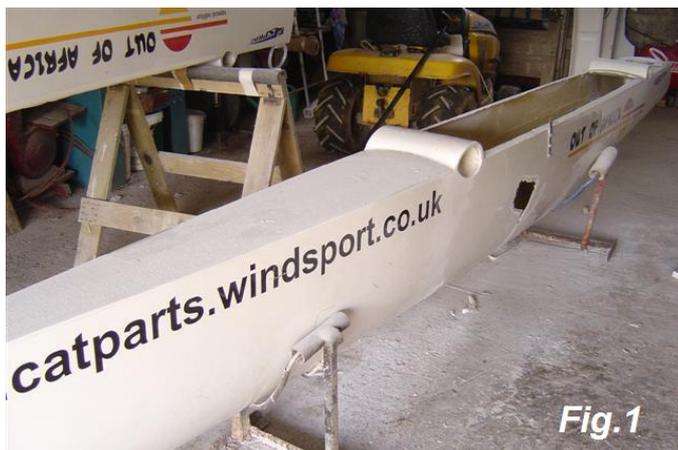
Fig.1

The damage had holed the boat on the port hull, broken away the spacer, dislodged the storage unit and put a nice Sprint 15 shaped vee in the hull side.

Fig.1:- Deck off , damage cut back , ready to start rebuild

With the deck off and the storage box out, the internal repair was started by cutting out the damaged area and laying up a temporary mould on the hull to replicate the hull shape. Using the same lay up as when the boat was built, a replacement section was moulded and laminated into place with a small overlap flange to the original hull edge.

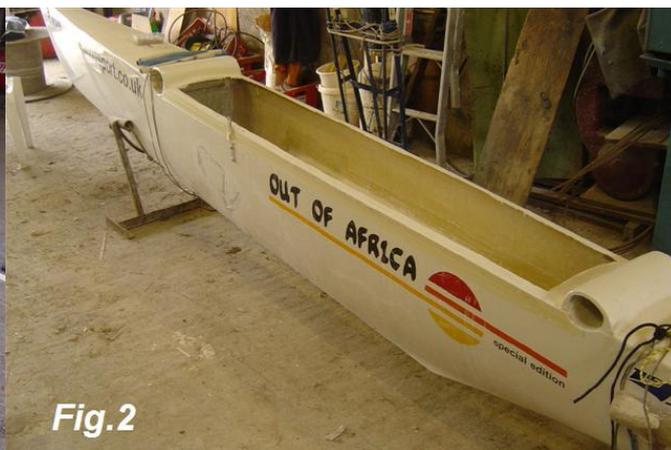
Fig.2

Fig.2:- Internal work done , ready to fit and replace deck unit.

With the inside hull work done, the flanges for holding the spacer in position were rebuilt and a

new spacer fitted. The boat was then ready for re-decking, although the deck and hull flanges needed a bit of attention so that they meet neatly.

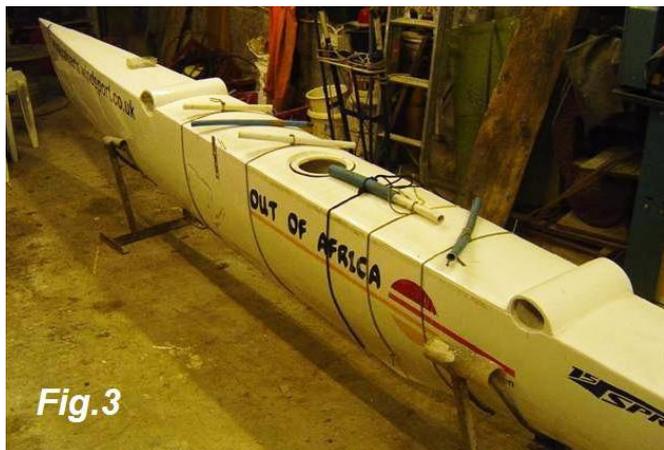
Fig.3

Fig.3:- Deck joint curing , while the "Spanish clamps" hold the deck line in position.

With the storage unit glassed back in position to the underside of the deck, a dry fit for the deck /hull join is a must. Originally the deck was attached whilst the hull was in a decking jig that could move the side of the hull in and out to match the deck line. That was not an option for us but careful use of Spanish clamps (well that is what we call them) had the desired effect and are simple to adjust.

With everything ready to go, the wet fit is made using a mix of gelcoat and resin as the bond. Timing of the mix is important, as you don't want to be chasing a mix that is going hard too quickly, and still fiddling with your Spanish clamps!!

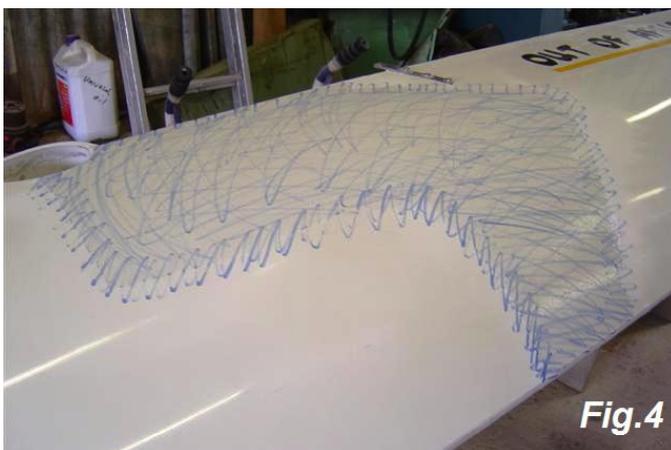
Fig.4

Fig.4:- Hull fairing taking place before final finishing.

Back to the outside of the hull, the damaged area needed fairing in, using gelcoat to build low areas, until the hull was smooth and fair from all angles. A good tip here is to use a felt tip over the area which gets rubbed off as you cut it back, something you can do with smaller repairs.

With the hull faired in, we ran a layer of spray gel over the area, blending it into the original. Colour match is tricky on any boat, unless it is very new, but white hulls have the best chance of making the repair invisible.

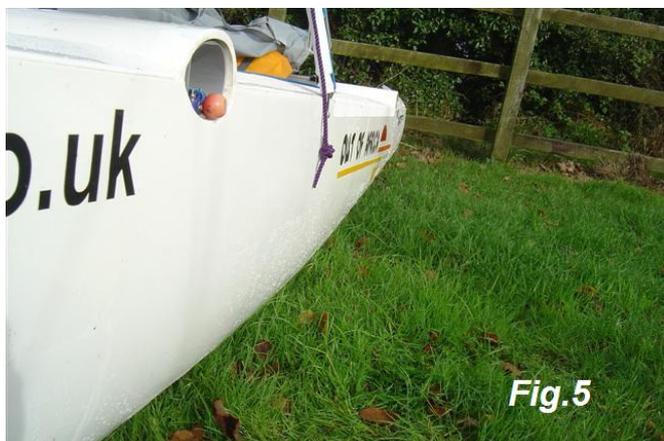
Fig.5

Fig.5:- Hull back on , and the boat ready to start racing again.

A final light cut back with 1200 paper, buff and polish, and the job was a goodun. It takes a few hours to do all this, and I would rather be sailing, but sometimes you just have to get on with it.
