"How to" service your rudder system Sprint 15 style.

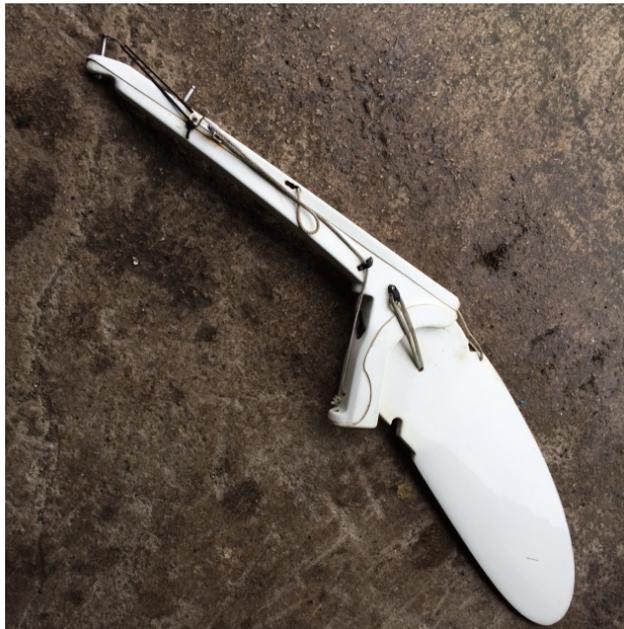
Top: the original all GRP rudder assembly as tested on Dart No. 1 - you can see the two connecting bar pins where they tested the length of the arm required. This unit is now held in the Windsport "Dart history" museum alongside the first ever Spark hull!

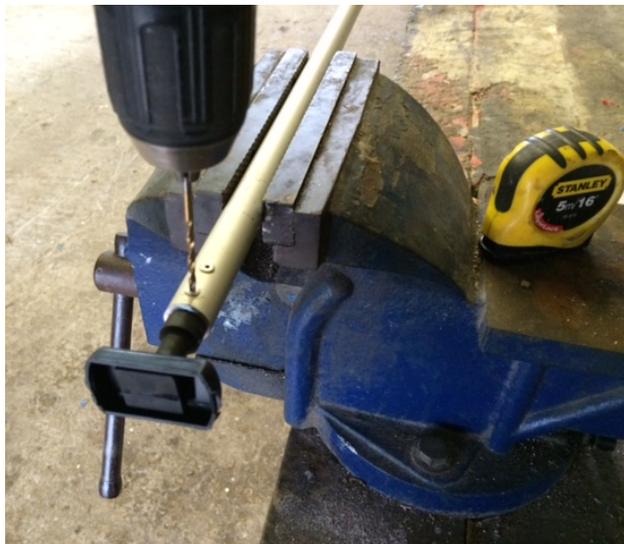
Middle: when replacing the tiller extension universal joint, only drill out the LOWER rivet.

1. Tiller extension: As long as it is still pretty straight and the rubber UJ is in good condition with no splits when you bend it, all's good. If the UJ looks tired, replace it before it fails at the wrong moment. Start by drilling out the lower 3.2mm rivet, pulling the old UJ unit out and with a bit of lubricant inserting a new one. Finish the job with the appropriate rivet expanded into the tube and the UJ.

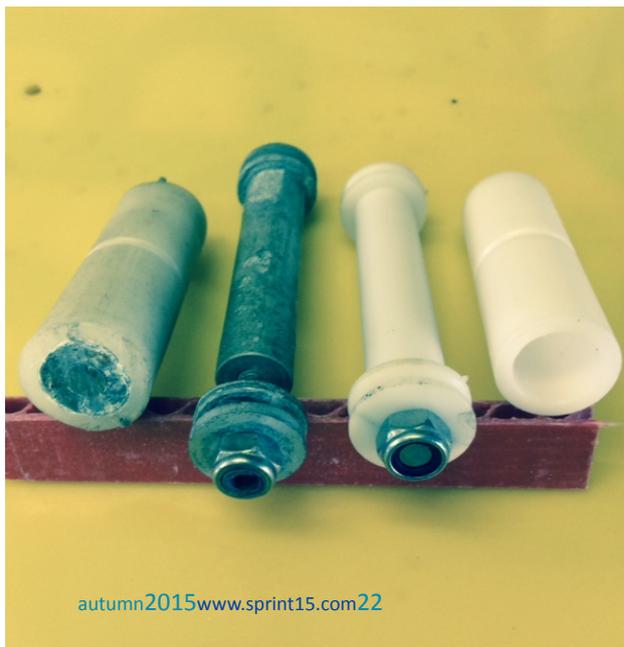
Left: corroded rudder bolt parts which are now replaced with the new style assemblies shown alongside

4 Rudder A frame: This is where it can get really interesting. This is the steering rack of the boat. It holds the blade in place and transfers your input to the rudder blade. Any movement in this area is exaggerated by the blade and tiller arm leverage. Remove the rudder unit from the stern and place the rudder blade in the lock down position. With the tip of the blade on a soft surface, establish any excessive movement at the rudder pivot point both left and right and forward and backwards. If any such movement is identified, replace worn areas such as rudder bolt washers, bolt sleeve, rudder buffer, etc.

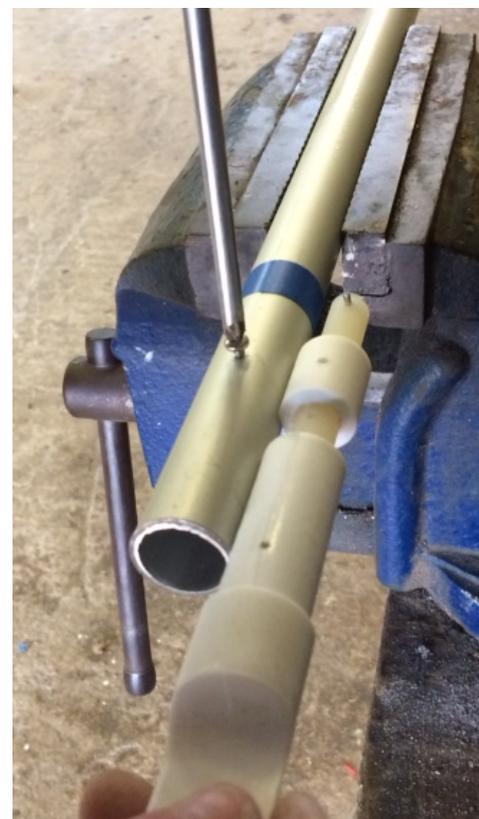
Right: if you decide to upgrade to the adjustable connecting bar, it's a simple process

2. Connecting bar: Check for corrosion across its length, in particular, around the tiller extension coupling point. Nearly all connecting bars have now been updated to the plastic ends which fit onto the short tiller pin on the tiller arm. The system is good and provides direct response, but if the plastic end is showing signs of cracking near the washer style hole, consider replacing. Again drill out the 4.8mm rivet and remove the original. You now have a choice - replace with a standard new plastic end item 02050 or upgrade to an adjustable end that allows you to align your rudder easily. The adjustable connecting bar end item 20028 comes with instructions and fixing. You may need to remove a small section of the connecting bar tube to provide the adjustment. Check out the website for the appropriate parts: www.catparts.windsport.co.uk

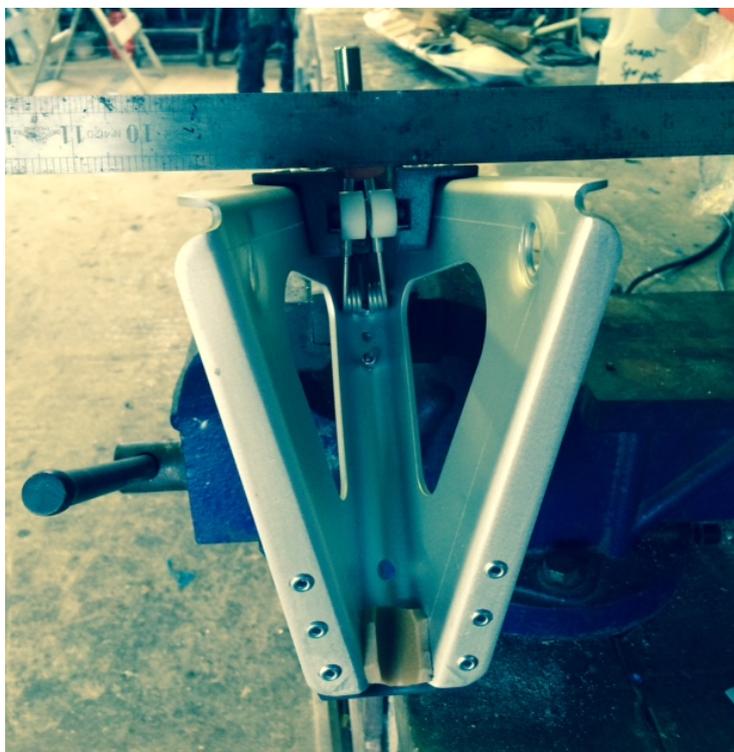
Left: rudder A-stock frame showing the lower rudder buffer and a straight edge checking that the pintle wings are parallel.

A frame which supports the blade low down and stops the blade from impacting the A frame front edge. Any lubrication should only be applied to the pintle sleeve and slider. No lubrication should be applied to the lock rollers themselves. Adjustment to the rudder kick-up is adjusted by filing the kick up anvil on the rudder blade. Filing a light groove across the anvil where the lock roller sits increases kick-up.

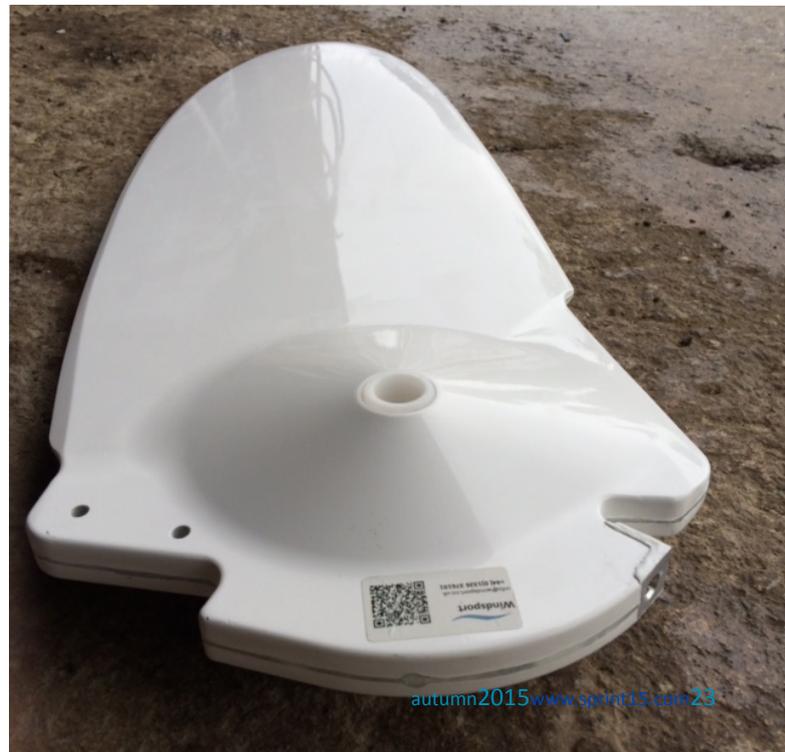
Right: a new production blade showing the foaming point on the blade's seam and lock roller anvil

6. Your rudder blade: Like the tyres on your car they need to be in good condition - chips, splits, warping, etc., all contribute to an unstable water flow across the blade and the faster the flow the more chance of disturbance and rudder stall. Older blades will be hollow with a breather hole in the head. New blades, as supplied by Windsport, are now foam filled providing a more stable and robust blade. External inspection of the blade is a good indicator but if you blow into the breather hole you can check the blade for any air holes or splits.
